GRANGER LAKE

FINAL FOUNDATION REPORT

EMBANKMENT-OUTLET WORKS-SPILLWAY

VOLUME-1
AUGUST 1983

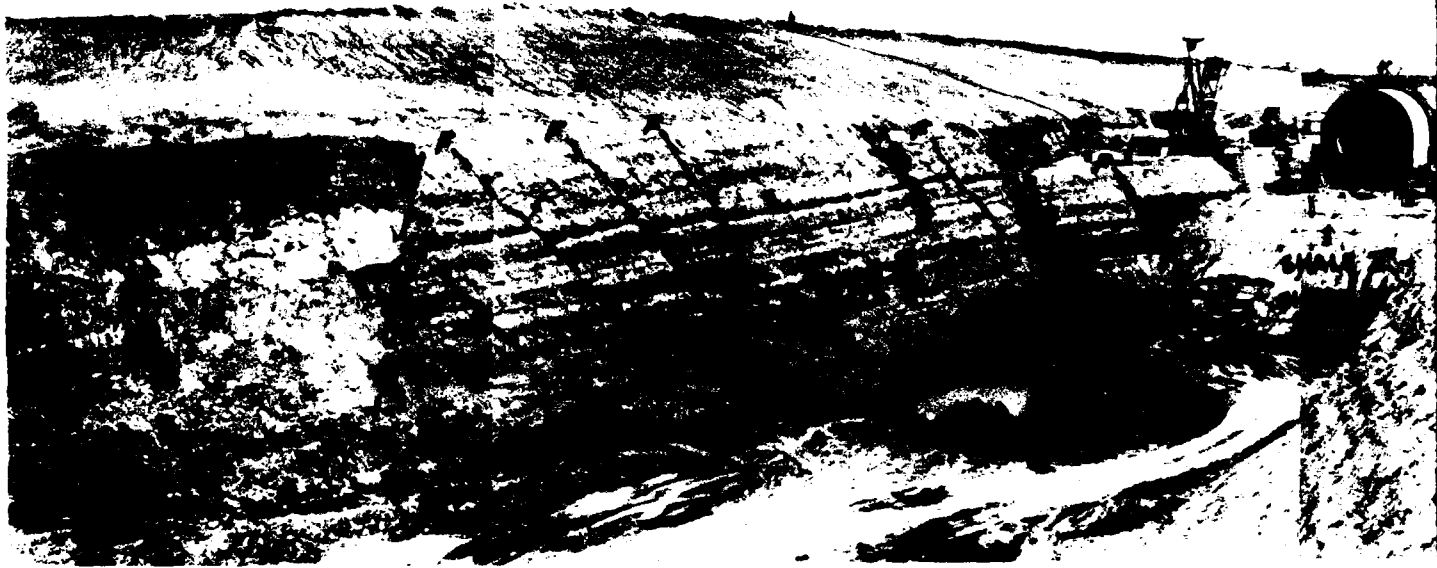
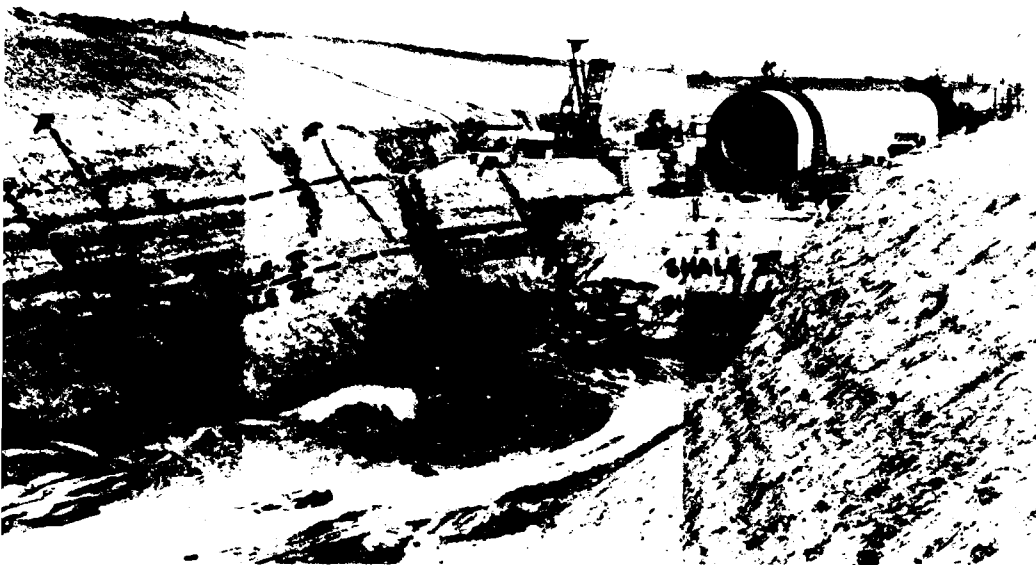
Five minor faults are present in the right (south) sideslope of the outlet stilling basin, having strikes very nearly the same as those of the Balcones system, but having an opposite direction of dip (upstream). See figures 36, 37, 38, and 39, and plate 30. These faults have maximum observed displacements of 2.0 feet (at the lower depositional seam). Their displacements diminish downward to disappearance of the faults before the Shale II/Shale III boundary is reached low in this sideslope. These faults, while having strikes much the same as those of faults of the Balcones system, may have developed earlier than those of the Balcones system, as one of them was observed to be terminated by the Balcones fault just downstream from the outlet stilling basin (figure 38). As far as can be discerned, these faults are present only in Shale II. Shale II is more brittle and susceptible to faulting than is Shale III below or Shale I, which once overlaid Shale II at this location.

Figure 37. Outlet works, 2nd contract: View of right (south) sideslope of the stilling basin and chute showing faults, lower depositional seam, and formation unit contacts.

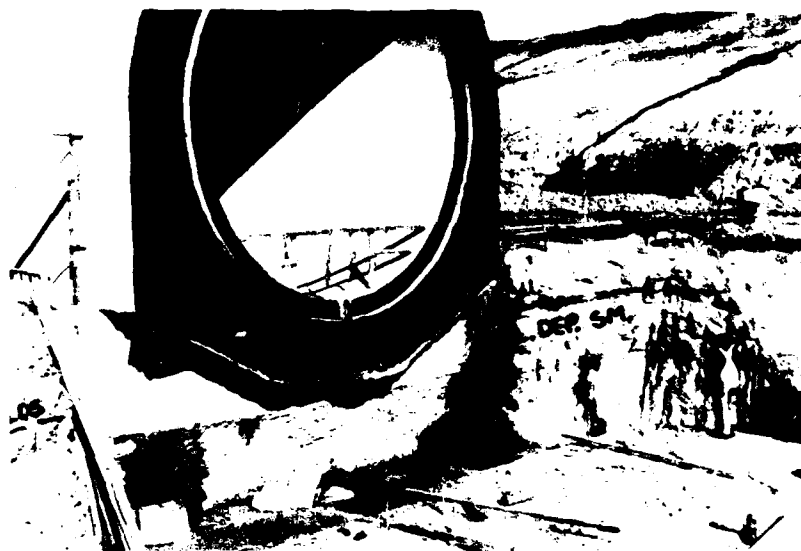
Figure 41. Outlet Works, 2nd contract: Downstream end of conduit and upstream end at chute foundation, showing lower depositional seam in sideslope of left manhole excavation.

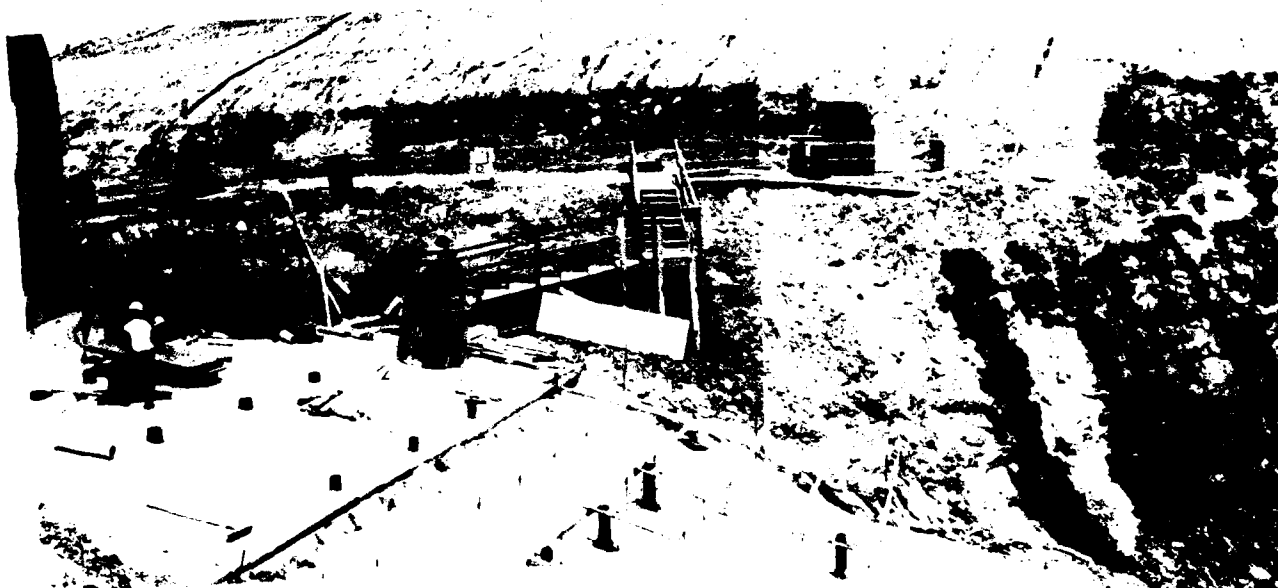
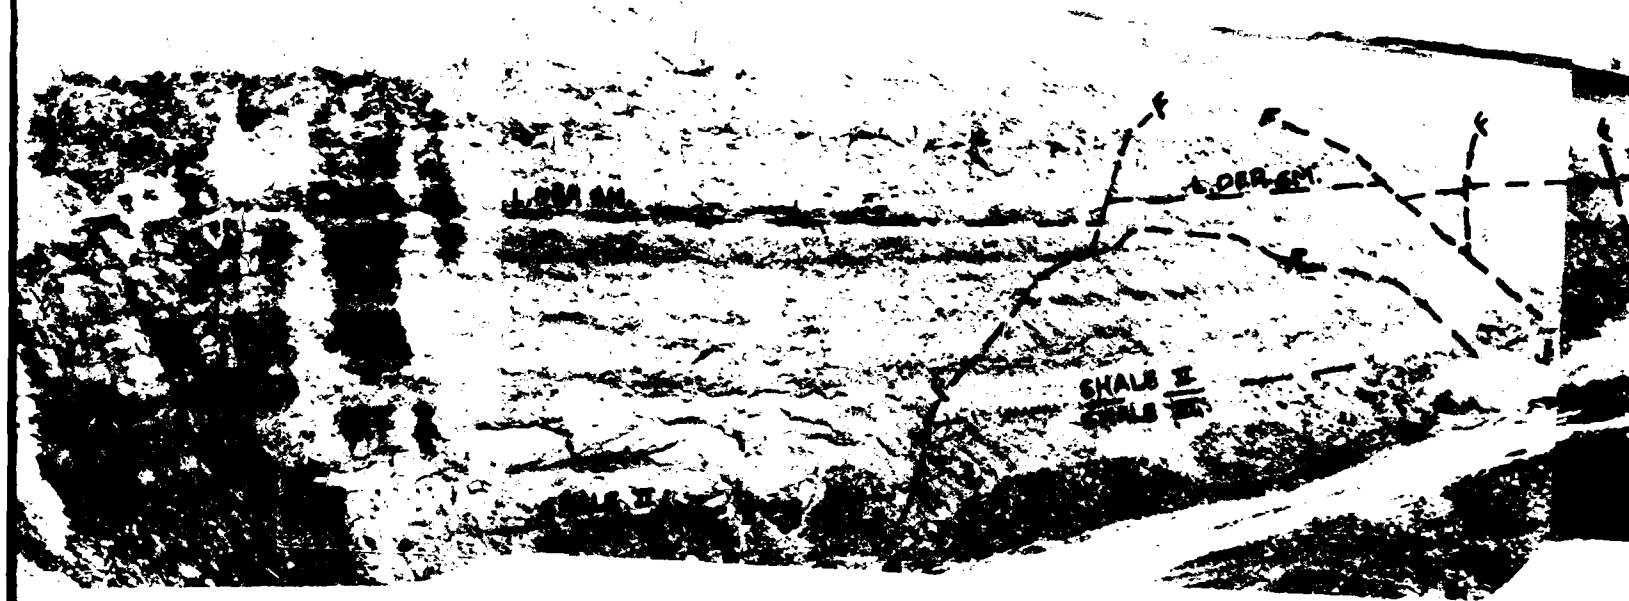
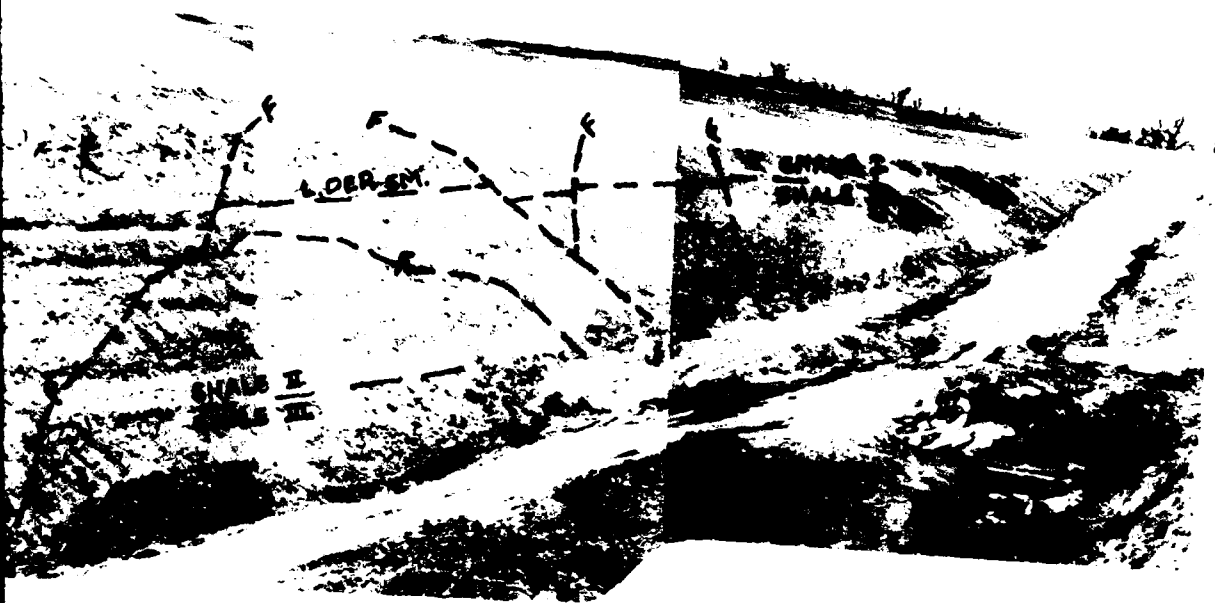
Figure 42. Outlet Works, 2nd contract: Left (north) sideslope of chute and stilling basin showing faults and the lower depositional seam.

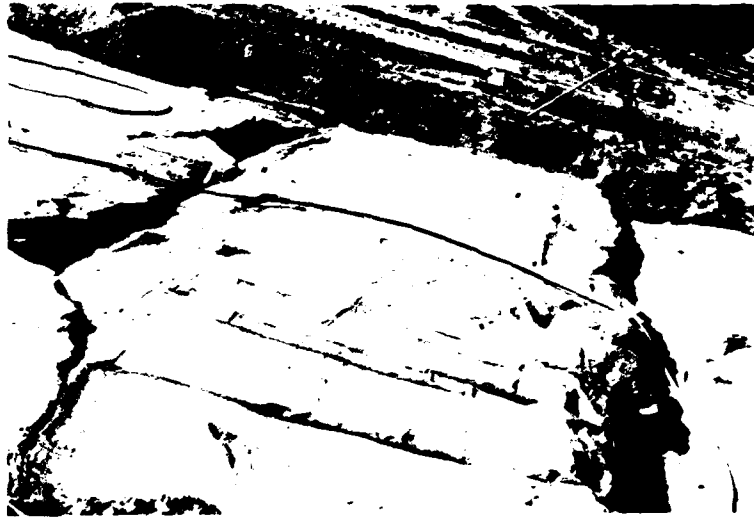
Seams of soft Shale I noted in the spillway are extremely thin (0.005+ foot) and may consist of minor softening of the shale along a bedding surface. There are only a few of these present, their recognition generally being restricted to the chute slope of the spillway. The two most notable of these, separated 3.9 feet vertically, extended from the left sideslope beyond the left wall, inward across the spillway to within 210 feet from the centerline of the chute. Their presence caused benches to be formed in the slopes by horizontal wedge-shaped pullout of shale blocks during excavation. See figure 66 and plate 33. These seams, where offset by the farthest left (north) fault, made accurate measurement of the vertical displacement of the fault possible (11.3 feet).

Figure 66. Spillway, 3d contract: Pull-outs caused by presence of two very thin, soft seams in the shale of the chute, which aided determination of fault displacement (see text).

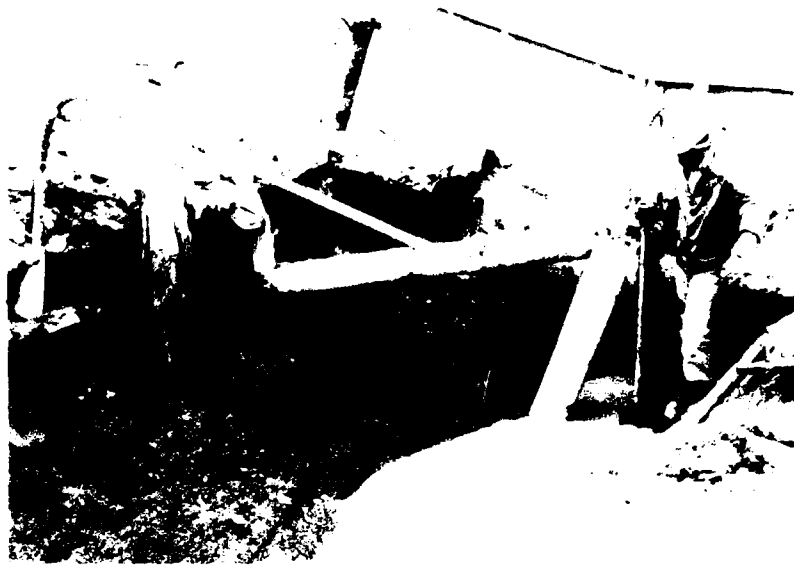
Figure 82. Spillway, 3d contract: View of slumped drainage blanket sand and resulting void under the work slab. Note: Water leaking from water-charged cross drainpipe. Site is next to left wall at foot of chute.

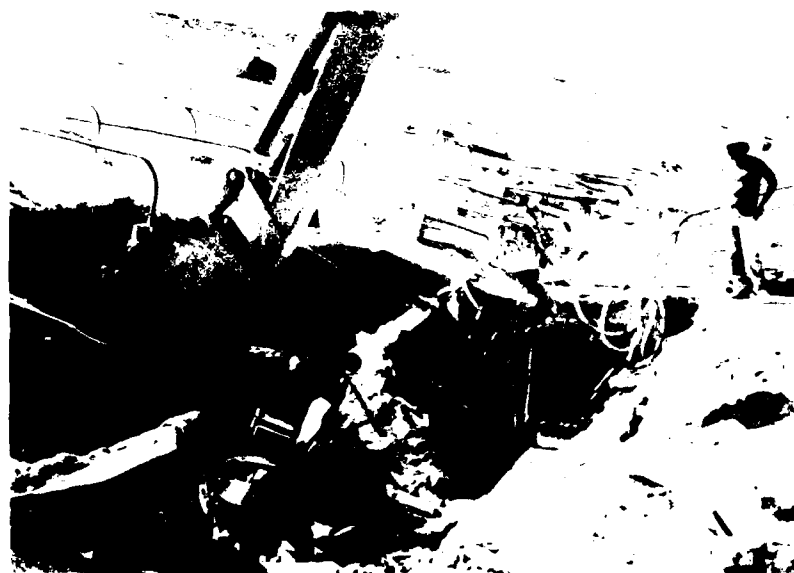
Figure 83. Spillway, 3d contract: Excavating manhole at offset 207.5 feet left at the base of the chute. Note void under the work slab both upstream and downstream from key concrete. Also key concrete reaching cross drainpipe.
